OFFICE OF AVIATION MEDICINE  
**FEDERAL AVIATION AGENCY**

AM 66-33

# RECOMMENDATIONS FOR SHOULDER RESTRAINT INSTALLATION IN GENERAL AVIATION AIRCRAFT

September 1966

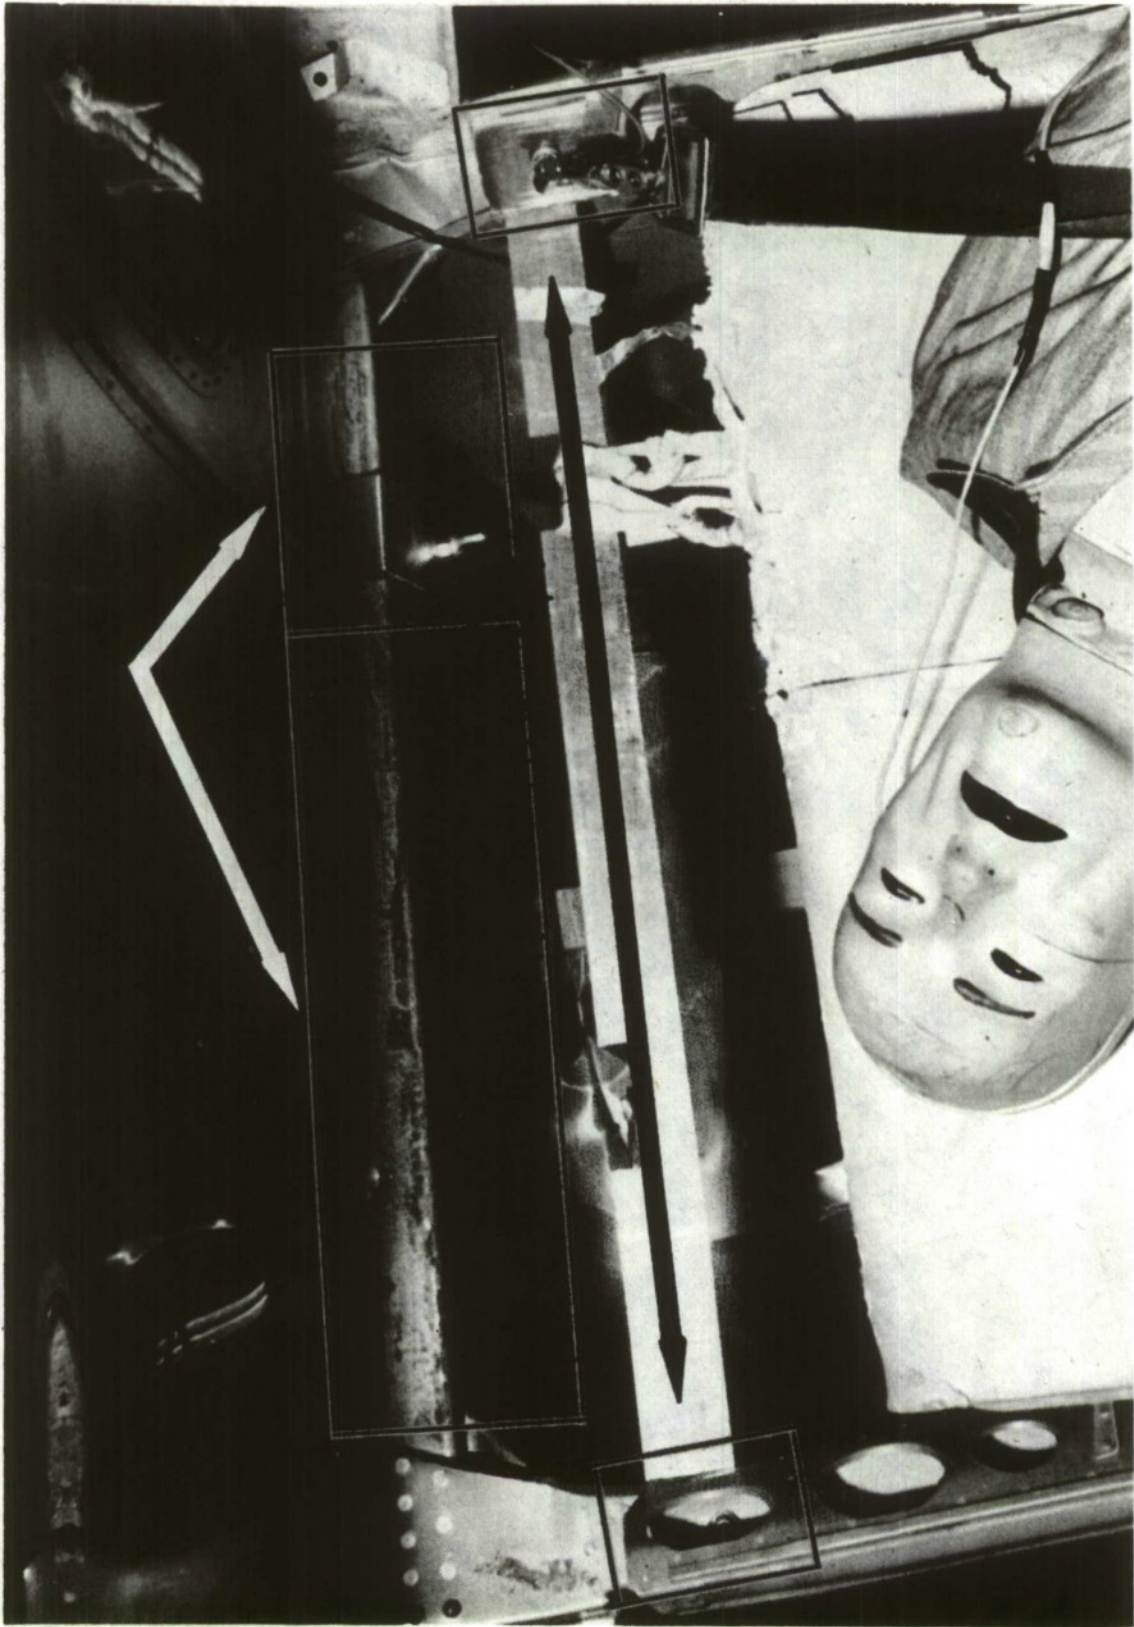
FIGURE 1. Cessna.

There are two primary structures in this aircraft that can be considered as reliable tie-down points for upper restraint belts. In Fig. 1, (All figures, 1 through 19, are in the Appendix.) both structures are outlined and an example of attachment hardware is demonstrated. The posterior wing support passing along the overhead from side to side forms a continuous structural projection (area indicated by white arrows) that can accommodate a "U" clamp for restraint

attachment. A clamp of this type can be centered behind the seated occupant if a double over-the-shoulder restraint belt system is used and attached to a single tie-down. In addition, dual clamps can be properly spaced to connect each belt separately if desired.

In the event a single diagonal shoulder belt is chosen, excellent side attachments can be made by utilizing the vertical frame posts formed at the aft edge of each door (indicated by the black arrow). These posts with circular cutouts form a reliable attachment location with the use of double plates bolted over the uppermost hole. Rectangular shaped plates extending beyond the edges of the cutout increase the structural strength, and when bolted together through the cutout center by an eyebolt, provide a convenient ring attachment.

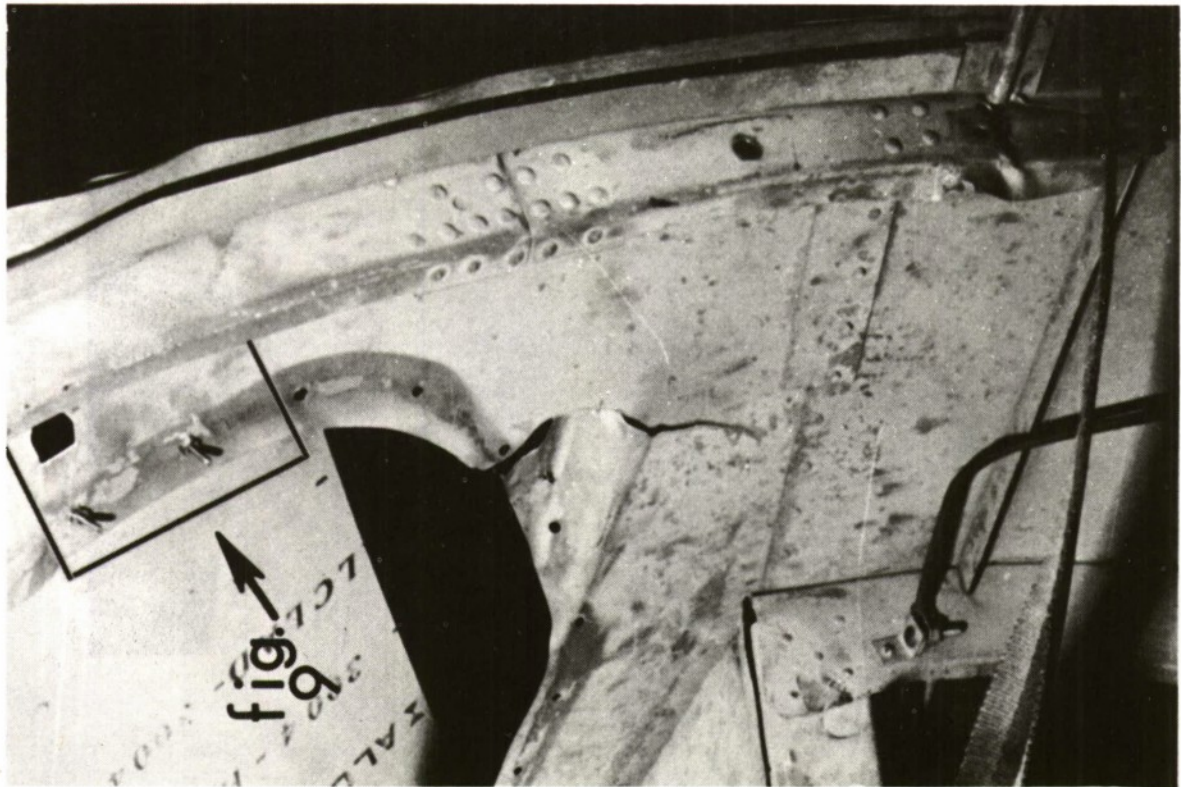
Side locations can also be used as indicated in Figs. 9 and 10. They would, however, require penetration of the skin with external backup plates for mounting. The mounting technique is essentially the same as in the center post situation. An example of this tie-down demonstrated in Fig. 9 shows the eyebolt as both the mounting bolt and attachment ring.

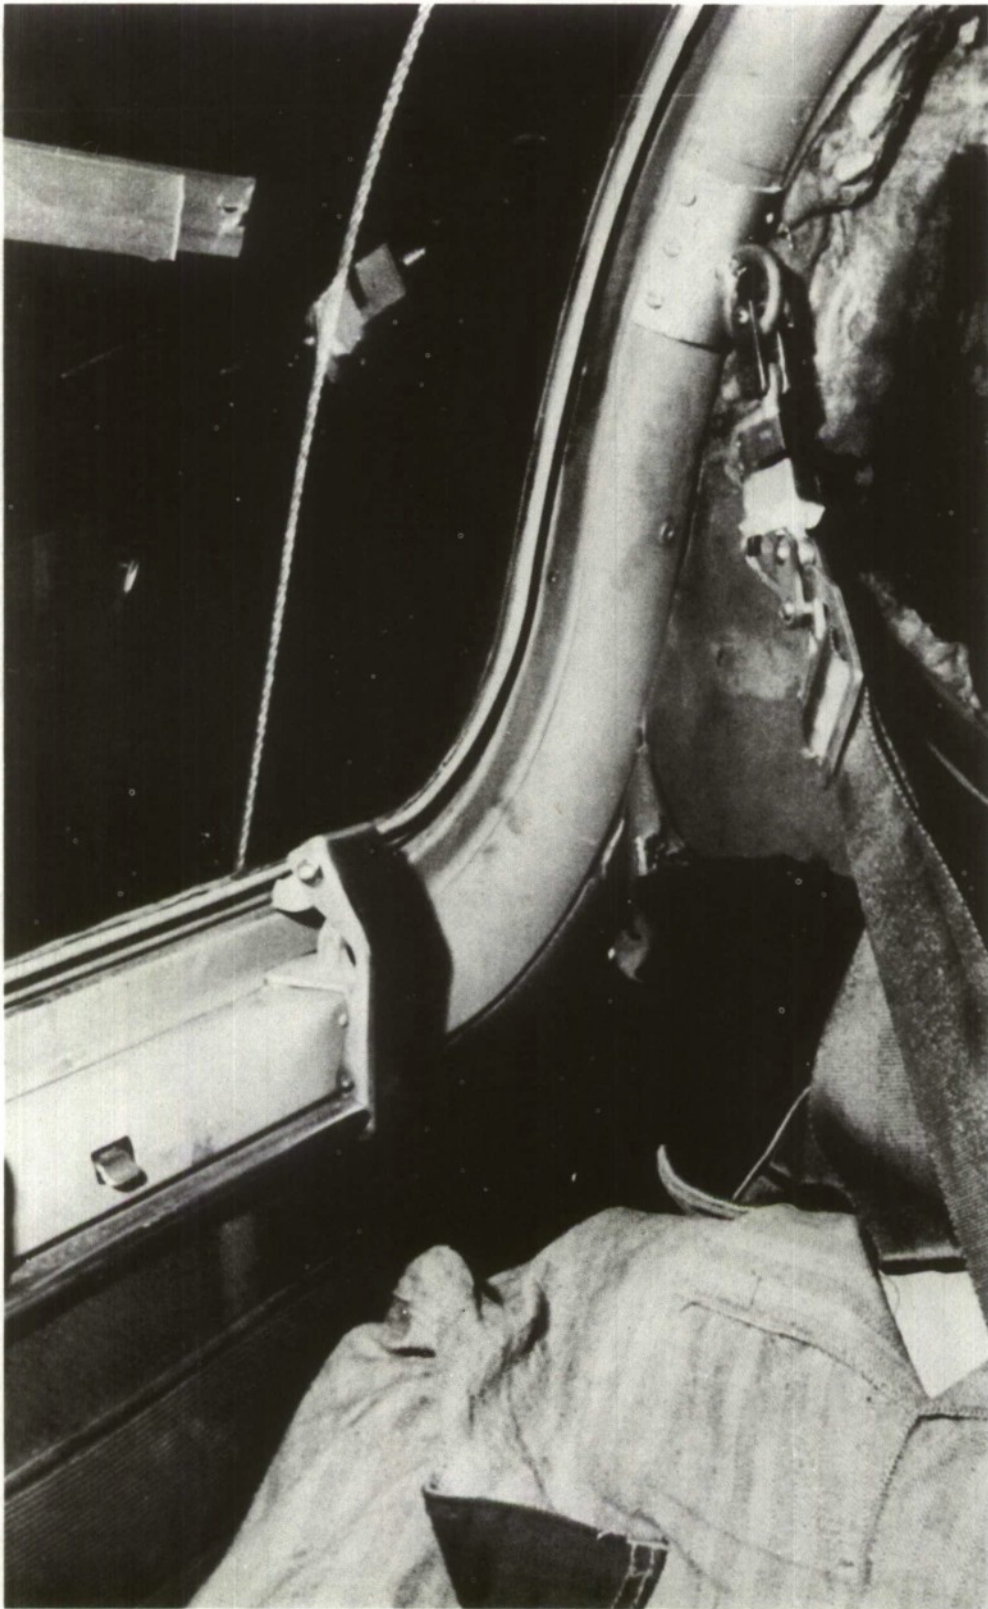
The best rear seat attachment locations were found to be on the rear window frame indicated by Figs. 16 and 17. Again, a metal plate bent to conform to the frame contour with a mounted attachment ring is used. This particular plate is held in place by sheet metal screws.
